**Flood Control Project Maintenance
Levee Inspections**

Maintenance Issue Types Only, Levee Inspection Report By Mile - Spring 2018

Reclamation District No. 0551 Pearson

Waterway	Bank	Unit Miles	Inspection Start/End	Inspector
Unit No. 01 Sacramento River	Left	6.78	03/21/2018 03/21/2018	Keith Millard

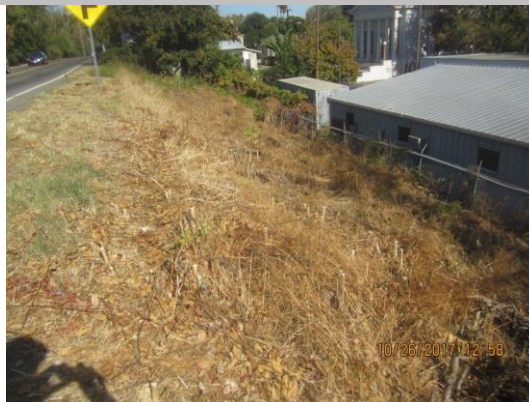
Photo 1 of 2 : SP_2018_RD0551_175_19_20180305_00007.jpg

LM Start	0.49	Rating **	A/W	Issue No.	19
LM End	0.49	Issue Type +	Ma	Location *	LS
Category	Earthen Levee			GPS Latitude/Longitude	
				Start	End
Item	Vegetation			38.331078 °	38.331078 °
				-121.570703 °	-121.570703 °
DWR ID	DWR_RD0551_01_f_2017_19				
Comment Code					
V2 : Remove the wild growth other than native grasses from the levee slopes.					
Inspector Comment					
Dense landside vegetation has been cleared and should be maintained.

Tall landside vegetation has been cleared.

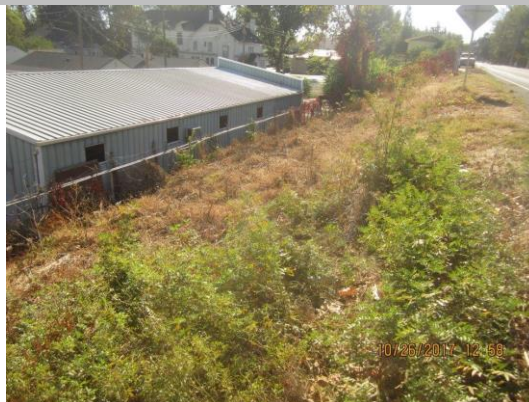
Photo 2 of 2 : SP_2018_RD0551_175_19_20180305_00008.jpg

Tall landside vegetation has been cleared.

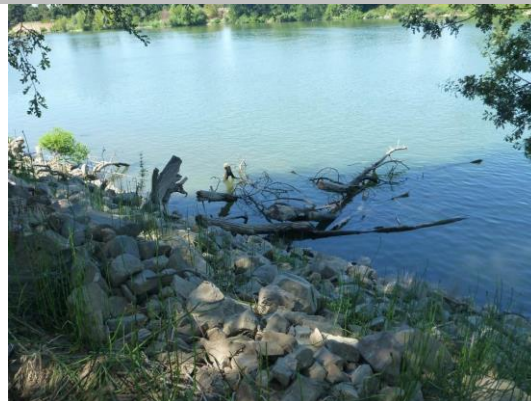
Photo 3 of 3 : SP_2018_RD0551_175_18_20180305_00006.jpg

Comment Code					
Inspector Comment					
<p>Levee Evaluation Comments</p> <p>Description: District Station 84+15 to 87+60, Sec. 06, T. 5 N. R. 4 E., M.D.M. Approximately 135 linear-feet of erosion/sloughing exists along the waterside levee slope of the Sacramento River. Sloughing commences approximately 3/4 of the way down the slope from the crown and extends into the rip rap. Some existing rip rap has been pulled off in this section.</p> <p>Site ID No: 331</p> <p>Site Designation: LMA-158</p> <p>Repair Type: Erosion</p> <p>Rating: Area of Concern</p> <p>Field Date: 7/13/2017</p> <p>Notes: thorny veg on upper slope, light veg within rip rap. Crown is a paved road. 1 ft vertical scarp max just above rip rap so we rated it as a lower priority.</p>

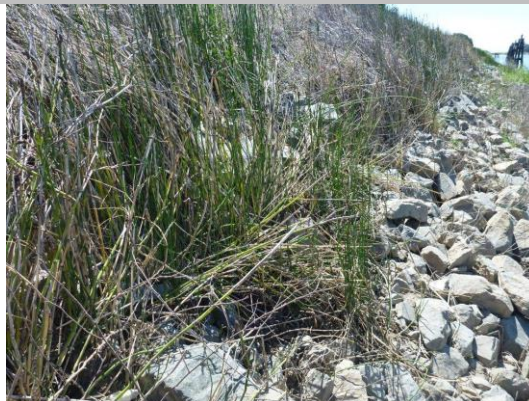
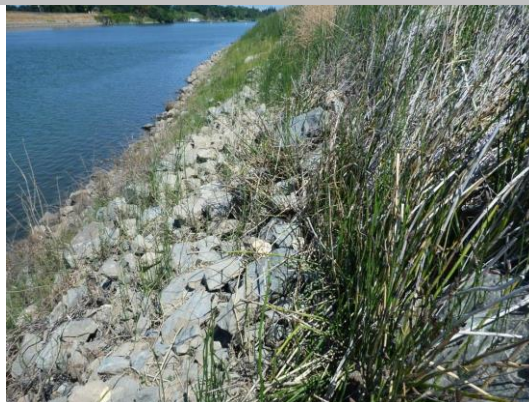
LM Start	2.71	Rating **	A/W	Issue No.	22 (cont)	
LM End	2.74	Issue Type +	Ma	Location *		
Category	Supplemental			GPS Latitude/Longitude		
				Start	End	
Item	2017 Storm Damage			38.301258 °	38.300922 °	
				-121.569550 °	-121.569258 °	
DWR ID	DWR_RD0551_01_f_2017_22					
Comment Code						
Inspector Comment						
Levee Evaluation Comments						
Description:District Station 142+31 to 143+80, Sec. 08, T. 5 N. R. 4 E., M.D.M. Approximately 149 linear-feet of erosion exists along the waterside slope of the Sacramento River. The erosion exists near the rip rap line about 3/4 of the way down the slope. Some existing rip rap has been pulled off in this section.						
Site ID No:332						
Site Designation:LMA-159						
Repair Type: Erosion						
Rating:Area of Concern						
Field Date:7/13/2017						
Notes: Crown is a paved road. Minor errosion right above and in the top of the rip rap.

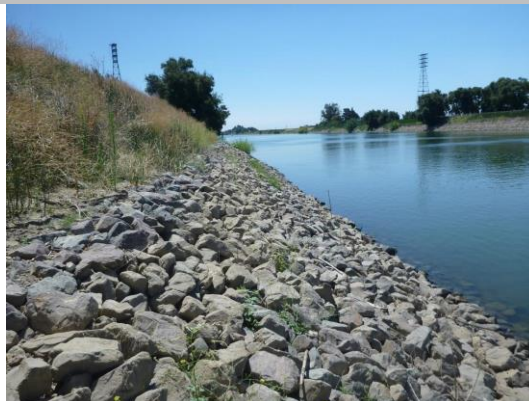
Photo 3 of 3 : SP_2018_RD0551_175_26_20180305_00017.jpg

Comment Code					
Inspector Comment					
<p>Levee Evaluation Comments</p> <p>Description: District Station 159+69 to 170+73, Sec. 08, T. 5 N. R. 4 E., M.D.M. Approximately 1,104 linear-feet of erosion and subsequent sloughing exists along the waterside slope of the Sacramento River. The erosion commences approximately halfway down the slope to the rip rap line.</p> <p>Site ID No: 333</p> <p>Site Designation: LMA-160</p> <p>Repair Type: Erosion</p> <p>Rating: Area of Concern</p> <p>Field Date: 7/13/2017</p> <p>Notes: Crown is a paved road. Thorny veg on upper slope, none in rip rap. Scarps upto 3 ft, mostly smaller, above rip rap. Area of concern because erosion is not too deep into prism and good rip rap protection on lower slope.</p>

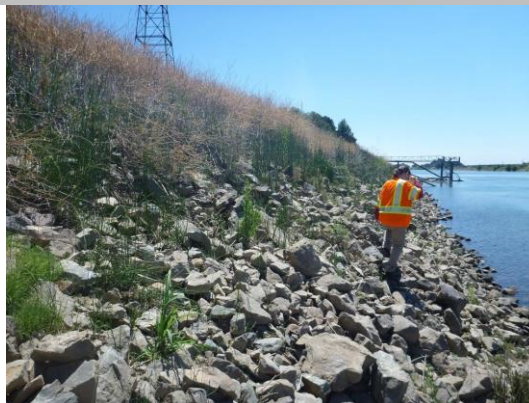
Photo 1 of 3 : SP_2018_RD0551_175_27_20180305_00018.jpg

Comment Code					
Inspector Comment					
<p>Levee Evaluation Comments</p> <p>Description: District Station 175+36 to 176+30, Sec. 08, T. 5 N. R. 4 E., M.D.M. Approximately 94 linear-feet of erosion exists along the waterside slope of the Sacramento River. The erosion occurs within the rip rap area near the waterline. Sloughing is exhibited in the in the bottom half of the slope. Some existing rip rap has been pulled off in this section.</p> <p>Site ID No: 334</p> <p>Site Designation: LMA-161</p> <p>Repair Type: Erosion</p> <p>Rating: Area of Concern</p> <p>Field Date: 7/13/2017</p> <p>Notes: Crown is a paved road. Scarps upto 3 ft within rip rap and 18 in above rip rap. Lower priority because erosion does not significantly cut into prism and damage was not continuous through whole site.</p>

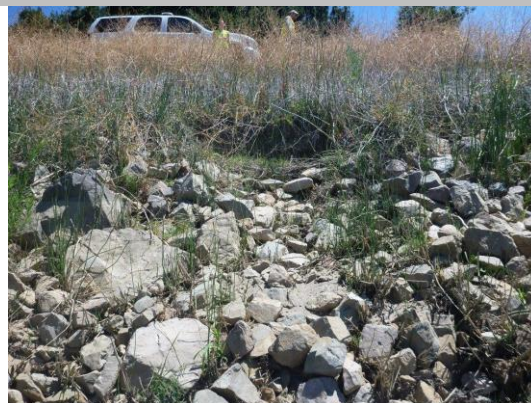
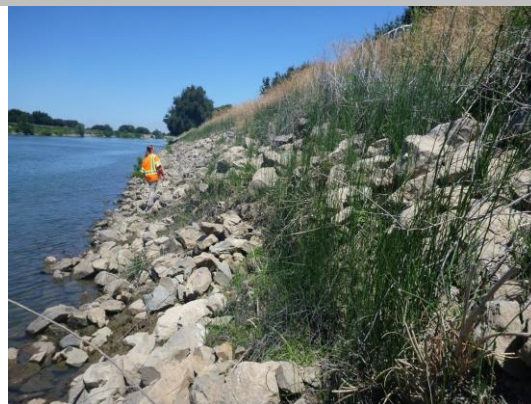
Item	2017 Storm Damage		38.293842 °	38.293642 °								
			-121.562917 °	-121.562708 °								
DWR ID	DWR_RD0551_01_f_2017_27											
Comment Code												
Inspector Comment												
<p>Levee Evaluation Comments</p> <p>Description: District Station 175+36 to 176+30, Sec. 08, T. 5 N. R. 4 E., M.D.M. Approximately 94 linear-feet of erosion exists along the waterside slope of the Sacramento River. The erosion occurs within the rip rap area near the waterline. Sloughing is exhibited in the bottom half of the slope. Some existing rip rap has been pulled off in this section.</p> <p>Site ID No: 334</p> <p>Site Designation: LMA-161</p> <p>Repair Type: Erosion</p> <p>Rating: Area of Concern</p> <p>Field Date: 7/13/2017</p> <p>Notes: Crown is a paved road. Scarps upto 3 ft within rip rap and 18 in above rip rap. Lower priority because erosion does not significantly cut into prism and damage was not continuous through whole site.</p>

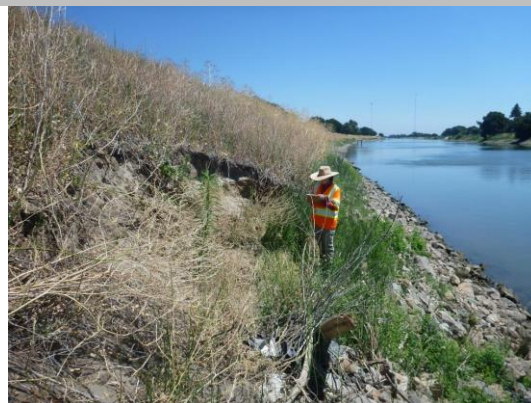
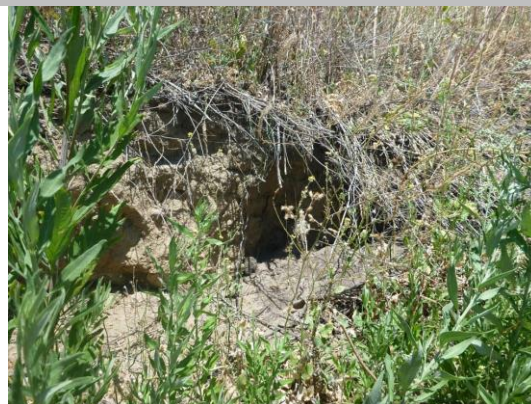
Comment Code					
Inspector Comment					
Levee Evaluation Comments					
Description:District Station 231+12 to 235+26, Sec. 16, T. 5 N. R. 4 E., M.D.M. Approximately 414 linear-feet of erosion and subsequent sloughing exists along the waterside slope of the Sacramento River. The erosion commences approximately 3/4 of the way down the slope to the rip rap line.					
Site ID No:336					
Site Designation:LMA-163					
Repair Type: Erosion					
Rating:Area of Concern					
Field Date:7/13/2017					
Notes: We only saw erosion on about 1½ the length reported by the LMA, but there is another site very close by. Crown is a paved road. Scarps up to 5 ft deep above the rip rap, mostly smaller though so rated this a lower priority site.

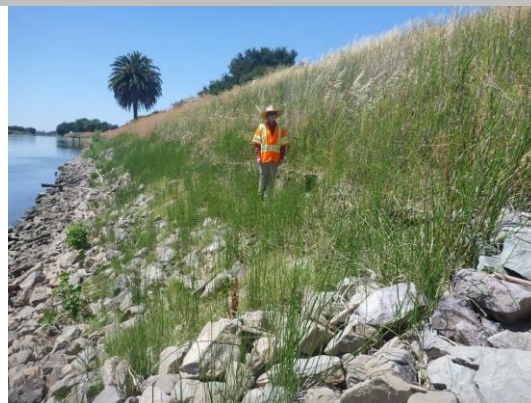
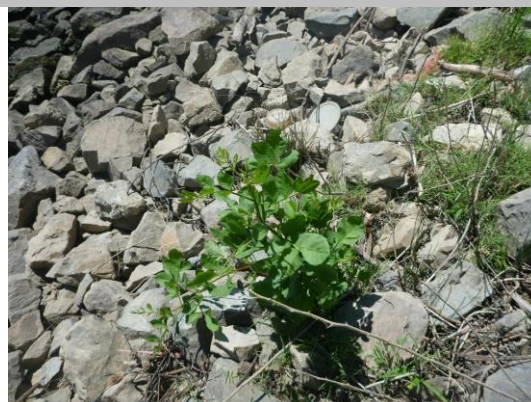
Comment Code					
Inspector Comment					
Levee Evaluation Comments					
Description:District Station 245+47 to 247+26, Sec. 16, T. 5 N. R. 4 E., M.D.M. Approximately 179 linear-feet of erosion and sloughing exists along the waterside slope of the Sacramento River. The erosion commences approximately halfway down the slope and extends to the rip rap. Some existing rip rap has been pulled off in this section.					
Site ID No:338					
Site Designation:LMA-165					
Repair Type: Erosion					
Rating:Area of Concern					
Field Date:7/13/2017					
Notes: Crown is paved road. Scarps up to 7 ft deep, 2 ft typical above the rip rap. Area of concern because the deeper scarp only covered a short distance and was already vegetated so not actively eroding.

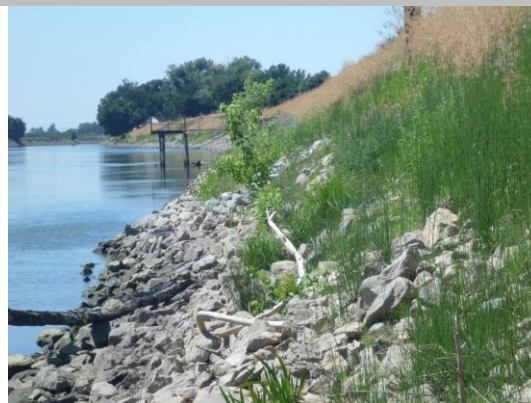
Photo 3 of 3 : SP_2018_RD0551_175_30_20180305_00029.jpg

Comment Code					
Inspector Comment					
<p>Levee Evaluation Comments</p> <p>Description: District Station 245+47 to 247+26, Sec. 16, T. 5 N. R. 4 E., M.D.M. Approximately 179 linear-feet of erosion and sloughing exists along the waterside slope of the Sacramento River. The erosion commences approximately halfway down the slope and extends to the rip rap. Some existing rip rap has been pulled off in this section.</p> <p>Site ID No: 338</p> <p>Site Designation: LMA-165</p> <p>Repair Type: Erosion</p> <p>Rating: Area of Concern</p> <p>Field Date: 7/13/2017</p> <p>Notes: Crown is paved road. Scarps up to 7 ft deep, 2 ft typical above the rip rap. Area of concern because the deeper scarp only covered a short distance and was already vegetated so not actively eroding.</p>

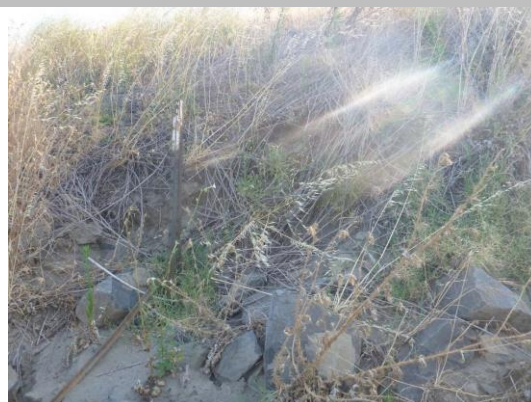
Photo 1 of 3 : SP_2018_RD0551_175_31_20180305_00030.jpg

Comment Code					
Inspector Comment					
<p>Levee Evaluation Comments</p> <p>Description: District Station 258+80 to 260+40, Sec. 16, T. 5 N. R. 4 E., M.D.M. Approximately 160 linear-feet of erosion exists along the waterside slope of the Sacramento River. The erosion commences approximately halfway down the slope from the crown and extends to the rip rap. Some existing rip rap has been pulled off in this section.</p> <p>Site ID No: 339</p> <p>Site Designation: LMA-166</p> <p>Repair Type: Erosion</p> <p>Rating: Area of Concern</p> <p>Field Date: 7/14/2017</p> <p>Notes: crown is a paved road. Scarps of 2.5 ft just above rip rap. Area of concern because erosion is fairly small.</p>

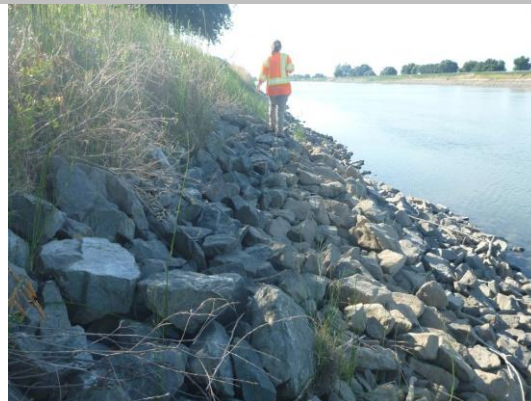
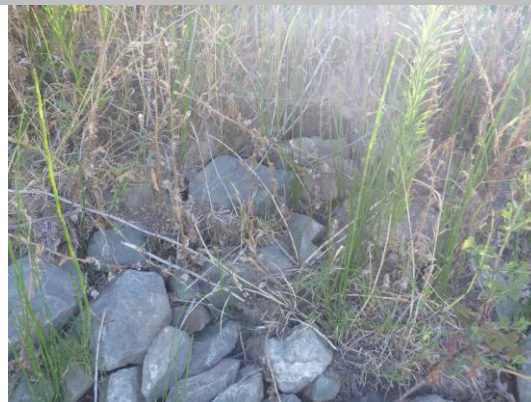
Comment Code					
Inspector Comment					
Levee Evaluation Comments					
Description:District Station 269+37 to 271+66, Sec. 21, T. 5 N. R. 4 E., M.D.M. Approximately 229 linear-feet of erosion and sloughing exists along the waterside slope of the Sacramento River. The erosion commences approximately 3/4 of the way down the slope from the crown and extends to the rip rap.					
Site ID No:341					
Site Designation:LMA-168					
Repair Type: Erosion					
Rating:Area of Concern					
Field Date:7/14/2017					
Notes: crown is a paved road. Scarps upto 4-5 ft, but 18 inches for most of the length. Large tree within site. Area of concern because deeper erosion is only present for a short distance.

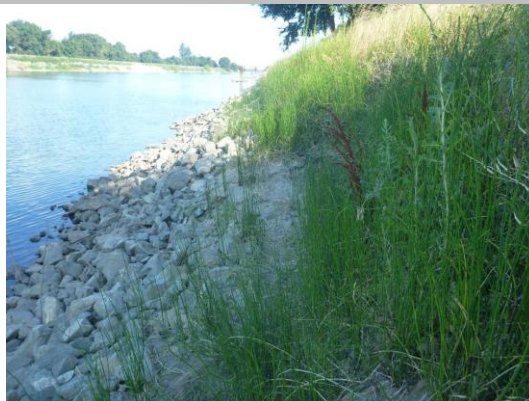
Photo 3 of 3 : SP_2018_RD0551_175_33_20180305_00038.jpg

Comment Code					
Inspector Comment					
<p>Levee Evaluation Comments</p> <p>Description: District Station 269+37 to 271+66, Sec. 21, T. 5 N. R. 4 E., M.D.M. Approximately 229 linear-feet of erosion and sloughing exists along the waterside slope of the Sacramento River. The erosion commences approximately 3/4 of the way down the slope from the crown and extends to the rip rap.</p> <p>Site ID No: 341</p> <p>Site Designation: LMA-168</p> <p>Repair Type: Erosion</p> <p>Rating: Area of Concern</p> <p>Field Date: 7/14/2017</p> <p>Notes: crown is a paved road. Scarps upto 4-5 ft, but 18 inches for most of the length. Large tree within site. Area of concern because deeper erosion is only present for a short distance.</p>

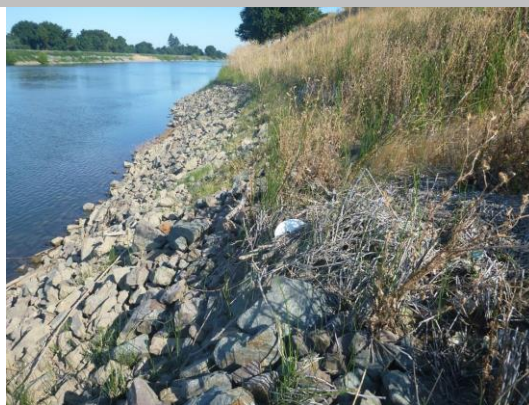
Photo 1 of 3 : SP_2018_RD0551_175_34_20180305_00039.jpg

Comment Code					
Inspector Comment					
<p>Levee Evaluation Comments</p> <p>Description: District Station 273+82 to 278+08, Sec. 21 and 22, T. 5 N. R. 4 E., M.D.M. Approximately 426 linear-feet of erosion exists along the waterside slope of the Sacramento River. The erosion commences approximately halfway down the slope and extends to the rip rap. Some existing rip rap has been pulled off in this section.</p> <p>Site ID No: 342</p> <p>Site Designation: LMA-169</p> <p>Repair Type: Erosion</p> <p>Rating: Serious</p> <p>Field Date: 7/14/2017</p> <p>Notes: there is a 7 ft scarp that extends for 40-60 ft in very sandy soil, scarps are 2-4 ft the rest of the length. Worst site in this RD so far. Serious because of the length of this deeper scarp and the weak soil here. Crown is a paved road.</p>

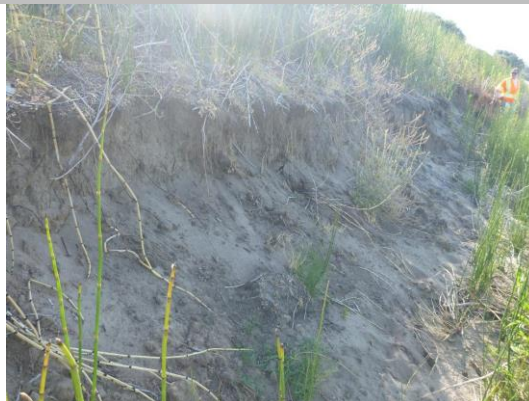
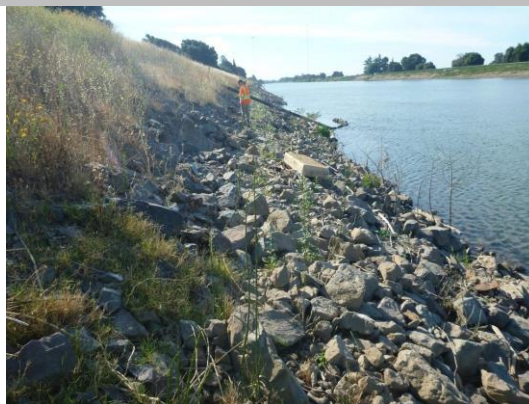
Comment Code						
Inspector Comment						
Levee Evaluation Comments						
Description:District Station 273+82 to 278+08, Sec. 21 and 22, T. 5 N. R. 4 E., M.D.M. Approximately 426 linear-feet of erosion exists along the waterside slope of the Sacramento River. The erosion commences approximately halfway down the slope and extends to the rip rap. Some existing rip rap has been pulled off in this section.						
Site ID No:342						
Site Designation:LMA-169						
Repair Type: Erosion						
Rating:Serious						
Field Date:7/14/2017						
Notes: there is a 7 ft scarp that extends for 40-60 ft in very sandy soil, scarps are 2-4 ft the rest of the length. Worst site in this RD so far. Serious because of the length of this deeper scarp and the weak soil here. Crown is a paved road.

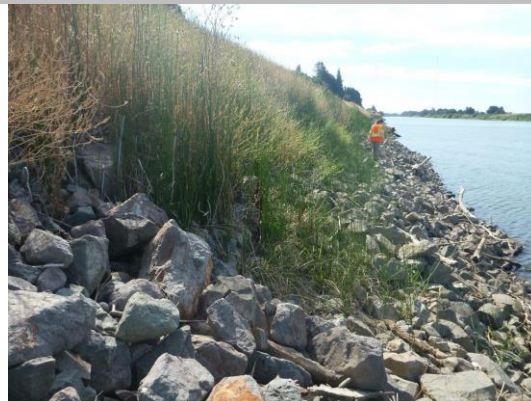
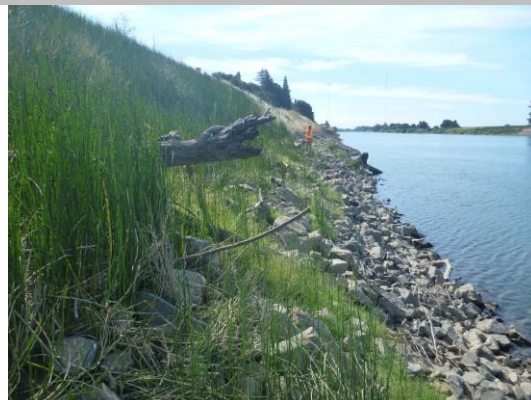
Comment Code					
Inspector Comment					
Levee Evaluation Comments					
Description:District Station 283+08 to 285+49, Sec. 22, T. 5 N. R. 4 E., M.D.M. Approximately 241 linear-feet of erosion and sloughing exists along the waterside slope of the Sacramento River. The erosion commences approximately 3/4 of the way down the slope and extends to the rip rap. Some existing rip rap has been pulled off in this section. Site ID No:343					
Site Designation:LMA-170					
Repair Type: Erosion					
Rating:Area of Concern					
Field Date:7/14/2017					
Notes: Crown is a paved road. Scarps above rip rap 2-4 ft deep, but not continuous through whole site. Area of concern because erosion is not very deep into prism and is not continuous throughout site.

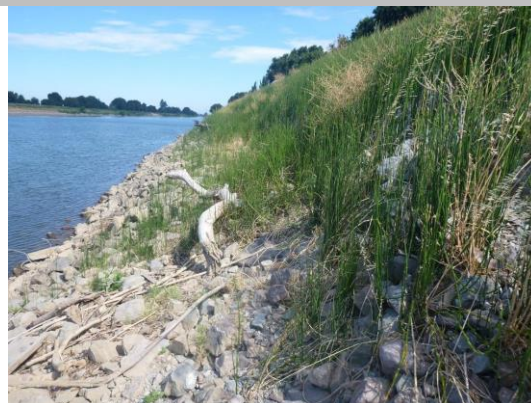
Photo 3 of 3 : SP_2018_RD0551_175_35_20180305_00044.jpg

Comment Code					
Inspector Comment					
<p>Levee Evaluation Comments</p> <p>Description: District Station 283+08 to 285+49, Sec. 22, T. 5 N. R. 4 E., M.D.M. Approximately 241 linear-feet of erosion and sloughing exists along the waterside slope of the Sacramento River. The erosion commences approximately 3/4 of the way down the slope and extends to the rip rap. Some existing rip rap has been pulled off in this section.</p> <p>Site ID No: 343</p> <p>Site Designation: LMA-170</p> <p>Repair Type: Erosion</p> <p>Rating: Area of Concern</p> <p>Field Date: 7/14/2017</p> <p>Notes: Crown is a paved road. Scarps above rip rap 2-4 ft deep, but not continuous through whole site. Area of concern because erosion is not very deep into prism and is not continuous throughout site.</p>

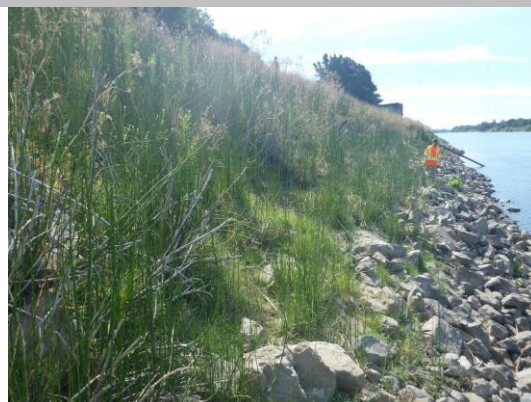
Photo 1 of 3 : SP_2018_RD0551_175_36_20180305_00045.jpg

Comment Code					
Inspector Comment					
<p>Levee Evaluation Comments</p> <p>Description: District Station 290+80 to 291+85, Sec. 22, T. 5 N. R. 4 E., M.D.M. Approximately 105 linear-feet of erosion and sloughing exists along the waterside slope of the Sacramento River. The erosion commences approximately 3/4 of the way down the slope and extends into the rip rap. Some existing rip rap has been pulled off in this section.</p> <p>Site ID No: 344</p> <p>Site Designation: LMA-171</p> <p>Repair Type: Erosion</p> <p>Rating: Area of Concern</p> <p>Field Date: 7/14/2017</p> <p>Notes: Crown is a paved road. Erosion scarps 1-4 ft deep just above rip rap. Area of concern because erosion is not very deep into prism.</p>
